OVERVIEW ON LANDSLIDE DISTRIBUTION ALONG BULGARIAN DANUBE RIVER BANK BETWEEN VIDIN AND NIKOPOL

*Nikolai Dobrev, Boyko Berov, Plamen Ivanov, Miroslav Krastanov,
Aleksy Benderev, Boyka Mihalkova*

Keywords: landslides, seismogravitational phenomena, Bulgarian Danube river bank

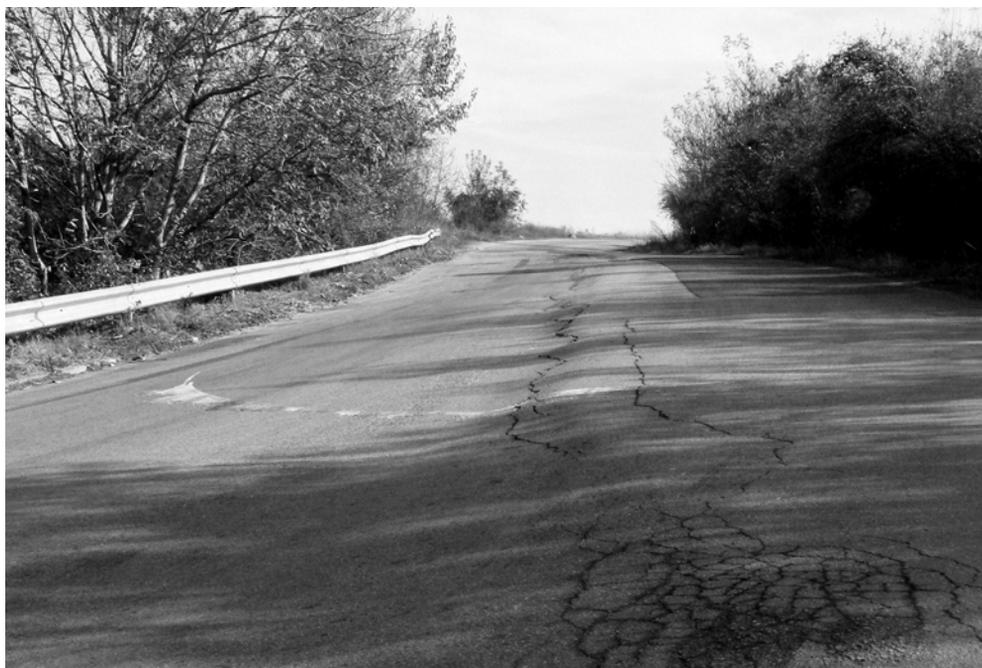
Landslide strip covers the right bank of Tsibritsa River at its lower course and slope above Gorni Tsibar Village. This is the most active part of the landslide in this sector. Continuing activity of this landslide is demonstrated by the deformations affecting road Lom – Kozloduy (Fig. 2). These are subsidences on the road and fresh cracks in places that show a high risk to to be interrupted if the

Fig. 2. Deformations affecting the road Lom – Kozloduy (30.10.2013)

movements continue. In the village, there are also observed cracks in buildings suffered as a municipality, where, according to the mayor, cracking continues in present days.

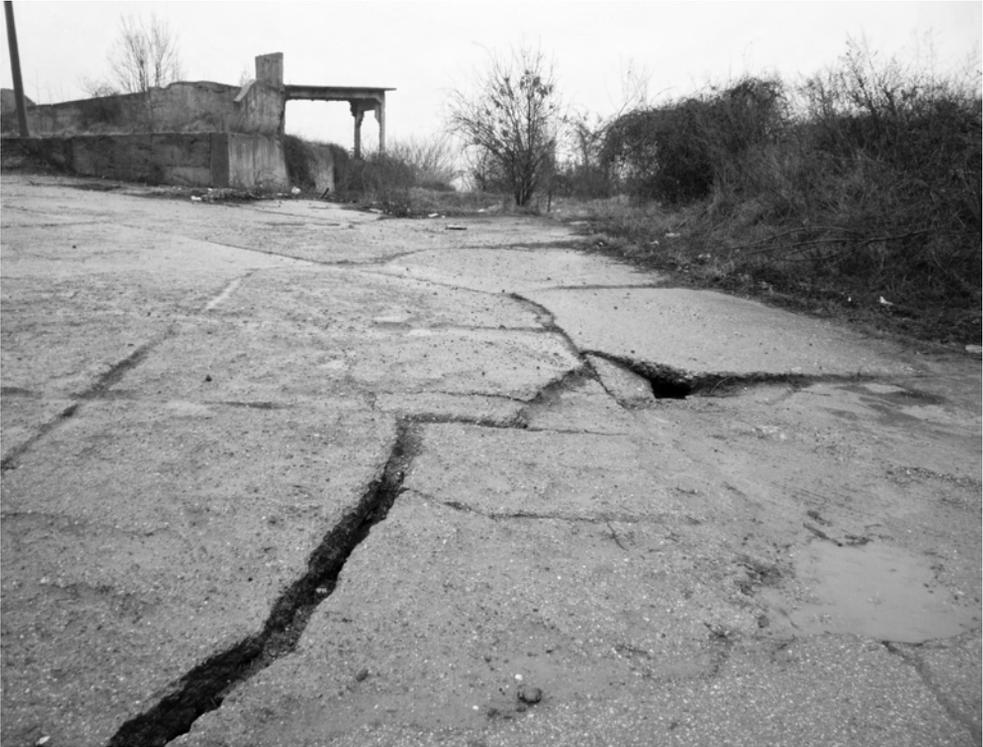
The town of Oryahovo is highly affected by landslides. In most part of houses can be seen cracks and deformations. Most intense movements have been established at the eastern part of Oryahovo (Figs. 3 and 4). On the road trace, fresh cracks showing serious subsiding have been identified. In this part there are destroyed old houses. The recent deformations reach the ferry port. There is a marshland between the road and the Danube river, which indicates that landslide is deep seated and the slip surface extends almost to the level of the river. Active landslide section has been established at Zelena Bara area, also at nearest Center for technical inspection of cars where the cracks in retaining walls and in asphalt road are exceeding 15 cm per year (measured for period March-November 2013).

Fig. 4. Deformations on the road at the Center for technical inspection of cars (07.02.2013)

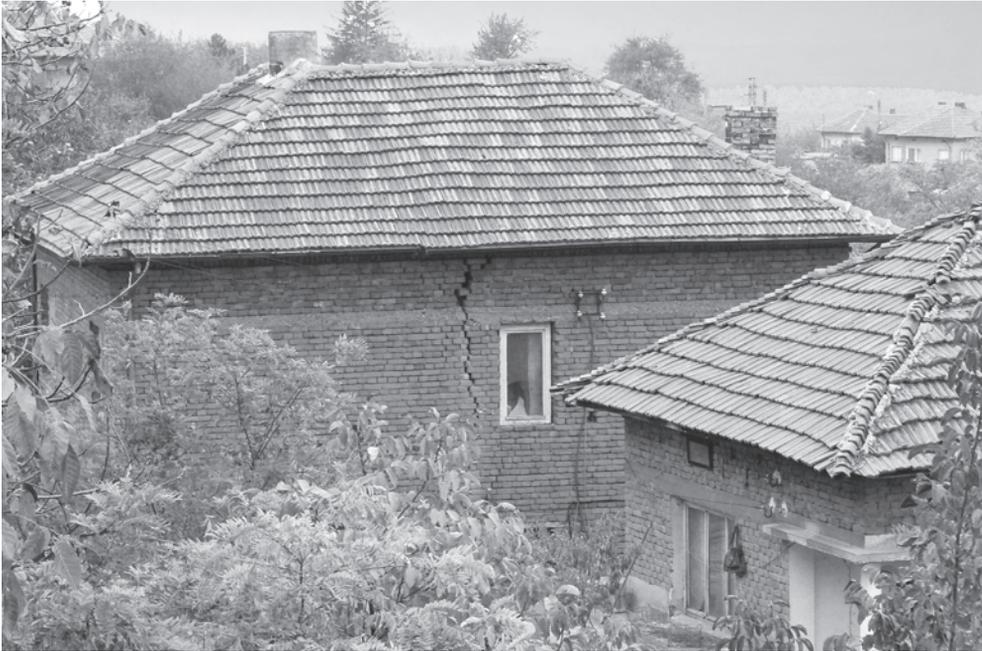
In the vicinity of Somovit Village two sectors in unstable conditions have been established. They are located in two large bodies of huge landslide cirques, which are in relatively stable condition (“dormant” type). But at some places fresh cracks in the houses of the village show an activity in present days (Fig. 5).

Fig. 5. Cracked house in Somovit village. The concrete slab is cut (21.10.2012)

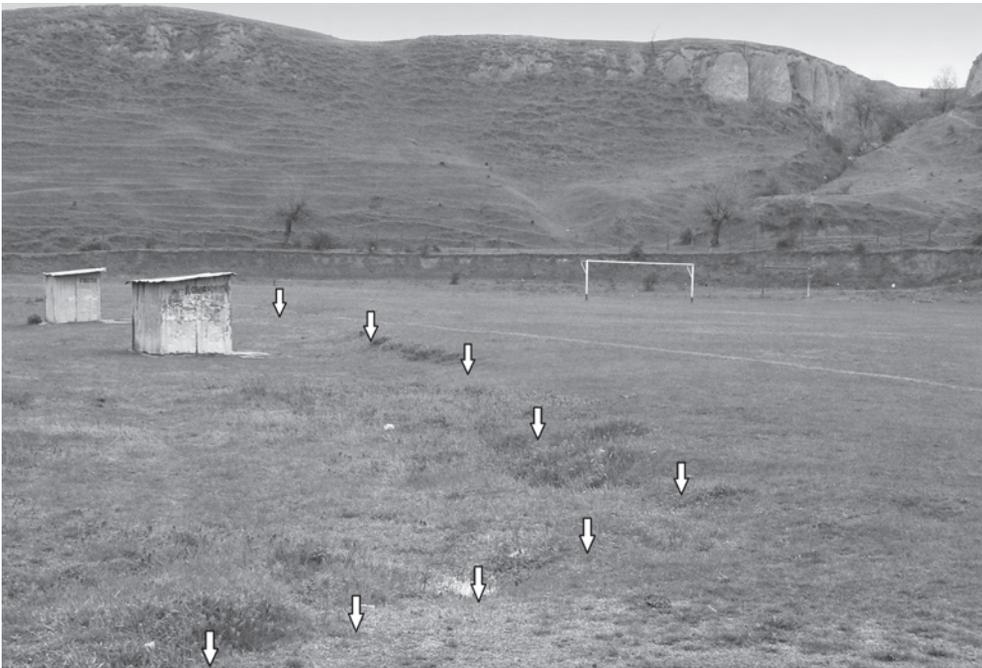
Recent activation of landslides occurred in 2006. A landslide is located about 300 meters east of the Russian monument. This slide however was relatively shallow, flow type, as much of the land mass been removed. At present there are no signs of moving, although some typical landslide geomorphological elements are clearly distinguishable in the field (Fig.6).

Fig.6. Landslide damages of stadium terrain, “Shipka street” Landslide, Nikopol Town (16.04.2013)

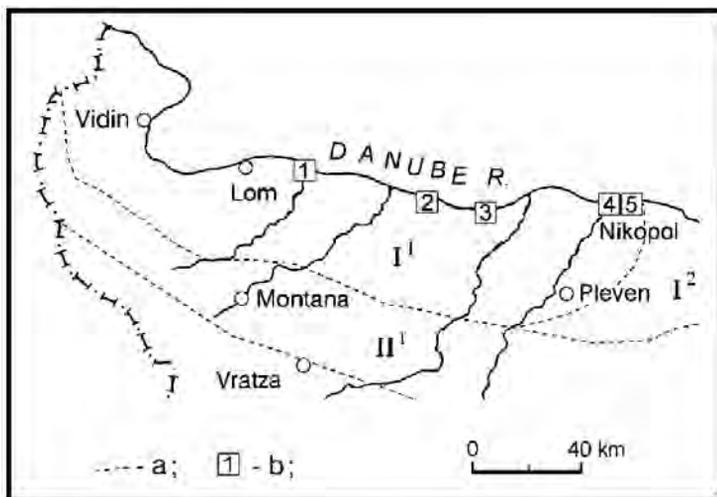
Earthquakes in this zone reach the Danube river bank of Bulgaria and subject it to macroseismic effects. This part of the territory of the country had been subjected to strong historic and contemporary earthquakes causing great human losses and destruction (Table 2, Fig. 7). A number of secondary seismogravitational phenomena and deformations of the Earth's crust are known which cause additional destruction (I l i e v, 1967; B r a n k o v, ed., 1983; R i z z o et al., 1986; F r a n g o v et al., 2007).

Fig. 7. Known seismogravitational phenomena in research area (modified after Frangov et al., 1998): a – boundaries of the regions: I¹ – Lom depression; I² – North Bulgarian rising; II¹ – Fore-Balkan area; b – case histories (macroeffects): 1 – Gorni Tsibar; 2 – Oryahovo; 3 – Gorni and Dolni Vadin; 4 – Somovit; 5 – Nikopol
